Micronised Silica Effects on Concrete of Substations

Keywords: micronised silica, mechanical properties, filler, durability

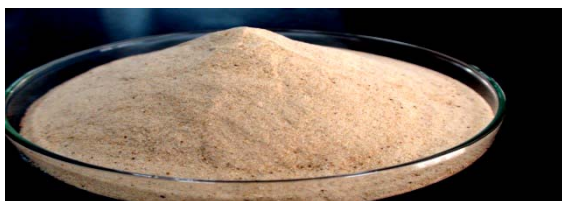
Figure 1- Micronised silica

the exploited silica (diorite) is equivalent to completely hydrated cement with a water to cement ratio of about 0.42 and is considered as a very low diffusive aggregate [1]. In 1958, researchers presented a diagram demonstrating the relations between permeability, strength, and porosity [9]. In this study, Micronised silica has been exploited as the filler in the concrete materials used in lamp posts and electricity transmission and distribution infrastructures, and its effect has been studied through the mentioned diagram and a series of experiments. Silica, with the chemical formula of SiO_2 , is the most abundant chemical compound in the earth's crust. Quartz is one of the poly-amorphs of silica which is stable in normal conditions of pressure and temperature; therefore, the silica is freely found in nature in the form of quartz. The material for the experiments have been provided through the Tahmasbabad silica mine, located in the rural area around Soltanieh, Abhar in the Zanjan Province, Iran; whose applications had previously been confined to abrasives, casting sand and glasswork. In order to produce Micronised silica, the silica ore extracted is modified, in the stages of crushing, milling and jet milling, into materials passing through a sieve with the grade of #200. Figure 1 presents Micronised silica and Figure 2 depicts Micronised silica particles shot by SEM microscope.

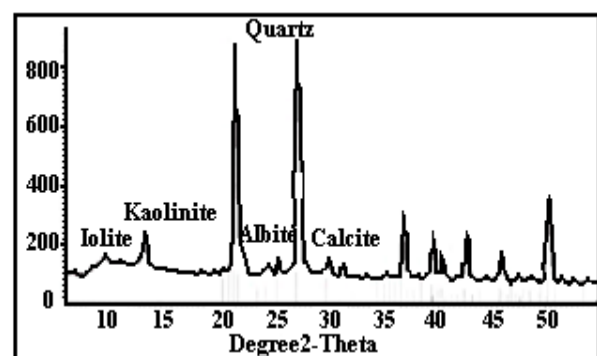
Figure 4- XRD test of Micronised silica

Aggregation diagram of Micronised silica and the cement used are illustrated in Figure 3. Besides, the chemical properties obtained from the XRF experiment of the Micronised silica are presented in Table 1. In addition, the results of the XRD experiment depicted in Figure 4, is also indicative of the crystal structure of the materials in use which prohibits the pozzolanic characteristics from emerging, and also results in a lack of reactivity with cement.

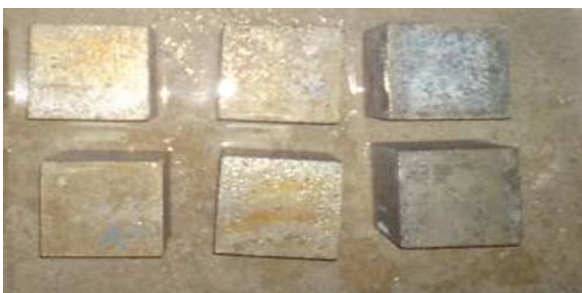
Figure 5- Built samples

Some of the samples were shown in figure 5.

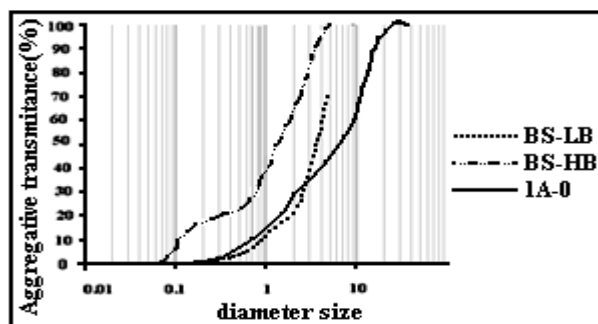
Figure 7- Grading curve of control sample of the first batch

The compressive strength experiment is one of the frequently used, most similar and most precise experiments in investigating the characteristics of the concrete. This experiment was performed on the samples in which Micronised silica had replaced aggregate. The results can be viewed in Figure 6 for the first batch including samples having the control sample with stated aggregation in Figure 7 (strength average of below 40 MPa), and at the ages of 7 and 28.

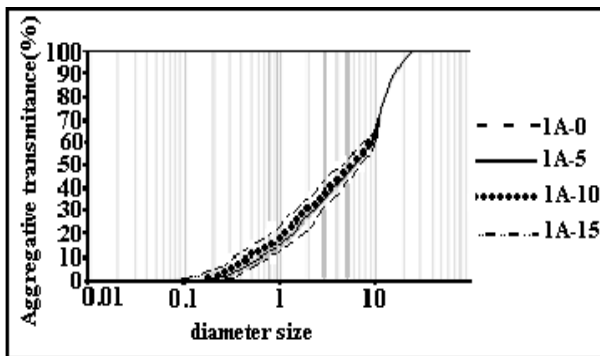
Figure 8- variation of aggregate grading of first batch

With regard to inspecting the effects of filler, only those parts of aggregation diagram which vary widely with replacement percentage of filler are adapted to the BS standard range. Besides, the diagram of aggregation changes caused by aggregate replacement by Micronised silica can be observed in Figure 8.

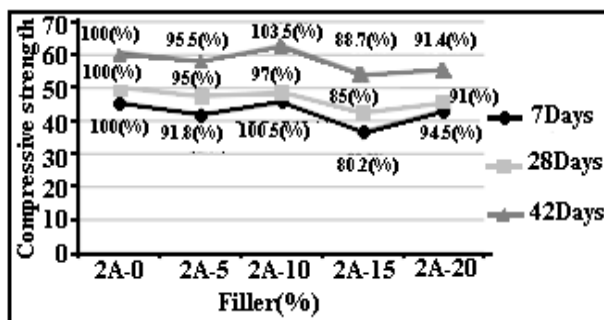
Figure 9- Results of compressive strength of second batch

The results in the second batch (strength average of around 50MPa) indicates a decrease in strength where control samples have the highest strength and as the replacement percentage of aggregate by Micronised silica increases, the strength decreases gradually. The diagram of aggregation changes, caused by replacement by the Micronised silica can be viewed in Figure 11.

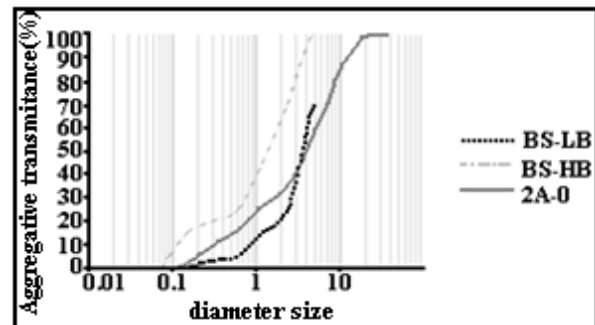
Figure 10- Grading curve of control sample of the second batch

As it can be seen, at the ages of 7 and 28 days, a sample with 15% replacement of aggregate by Micronised silica has the highest strength, where at the age of 7 days, the amount of growth of the strength compared to the control sample is 107.5% and at the age of 28 days the above-mentioned amount is 104.5%. Also in Figure 9, results of compressive strength experiment can be seen, at the ages of 7 and 28 and 42 days for the second batch including samples having control sample with stated aggregation in Figure 10 (strength average of around 50 MPa).

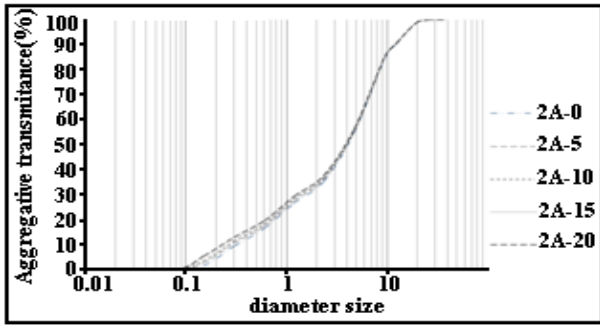
Figure 11- variation of aggregate grading of second batch

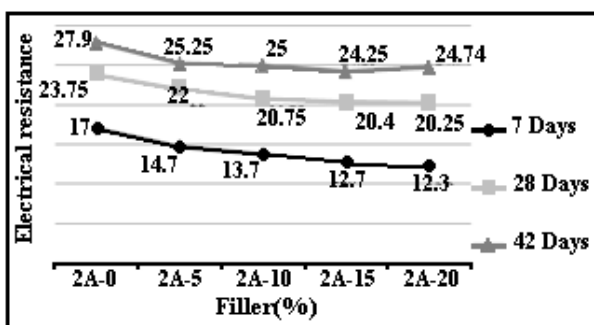
Figure 13-Electrical resistance of second batch (KΩ.cm)

results is presented as electrical resistance. In case the electrical resistance is more than 12 kilo ohms per centimeter, there is no possibility of corrosion, and in cases where it is less than 5 kilo ohms per centimeter, corrosion definitely exists and any value in between these two implies a possibility of corrosion. Figure 13 indicates the results of the concrete samples electrical resistance. As observed in Figure 13, as the replacement percentage of aggregate by Micronised silica increases the electrical resistance decreases.

With regard to Diagram 10 in each age, the control samples have the highest value of electrical resistance. This fact implies that the performance of these materials with their separate filler, effect resistance, permeability, and durability, which is disturbing to the proper hydration of the concrete.
